# Manhole Inspection Summary

Manhole # S25Q\_\_018MH

Insp Date: **4/9/08 10:26 AM**

**Location** Address: **1401 BAYARD ST.**

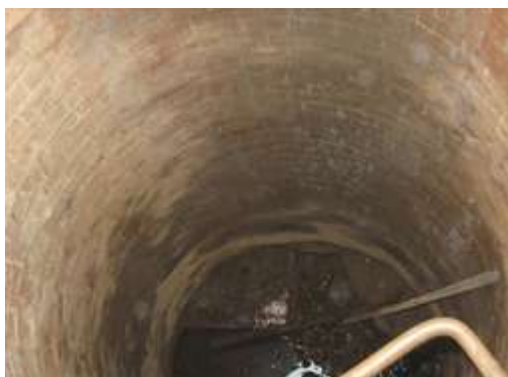
Defect 6

Infiltration: ☐ None ☐ Joint ☐ Cracks ☐ Mortar ☐ Roots ☒ **Wall**

EVIDENCE OF CORBEL AND BARREL INFILTRATION ON WALL

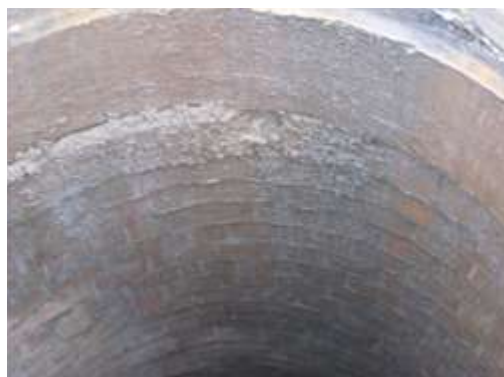
Defect 5

Infiltration: ☐ None ☐ Joint ☐ Cracks ☒ **Mortar** ☐ Roots ☐ Wall

MISSING MORTAR WITH EVIDENCE OF INFILTRATION AT THE CHIMNEY

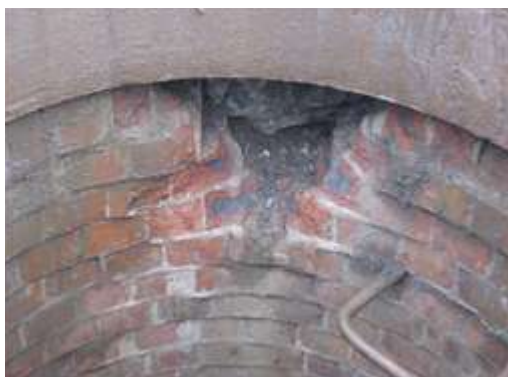
Defect 4

Condition: ☐ Sound ☐ Cracked ☐ Root Intrusion ☒ **Loose Brick** ☒ **Deteriorated**

Condition: ☐ Sound ☐ Cracked ☐ Root Intrusion ☒ **Loose Brick** ☐ Deteriorated

DETERIORATED CHIMNEY AND CORBEL WITH EVIDENCE OF INFILTRATION

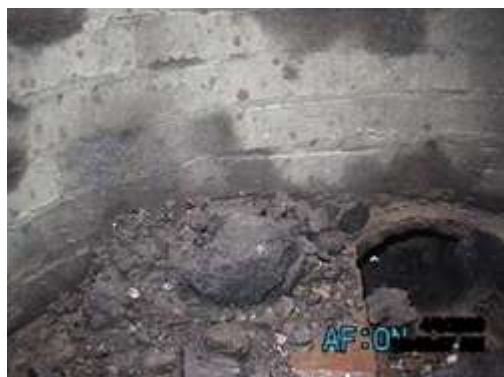
Defect 3

EVIDENCE OF BARREL INFILTRATION ON WALL

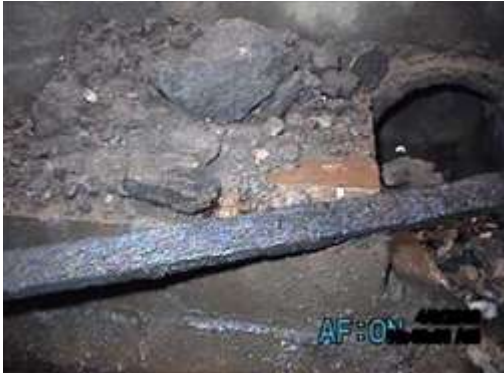
Defect 2

Condition: ☐ Sound ☐ Cracked ☐ Root Intrusion ☐ Deteriorated ☐ Leaks ☒ **Debris**

HEAVY DEBRIS ON THE BENCH

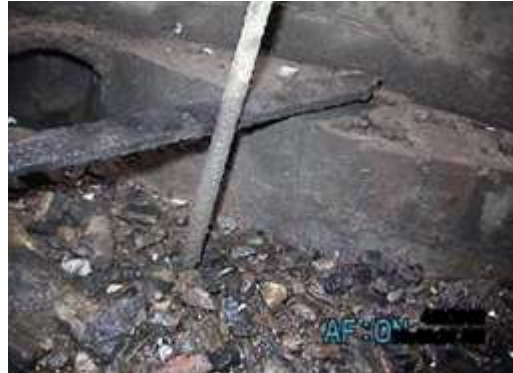
Defect 1

Condition: ☐ Sound ☐ Cracked ☐ Root Intrusion ☐ Deteriorated ☐ Leaks ☒ **Debris**

HEAVY DEBRIS IN THE CHANNEL

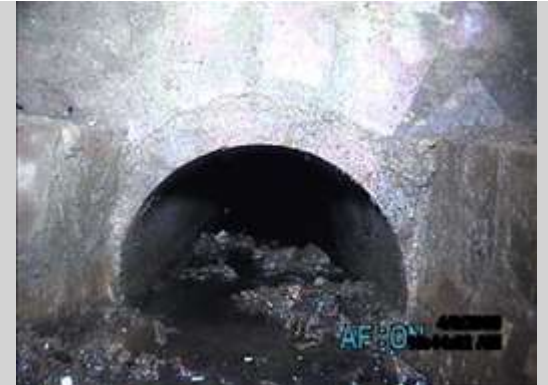
12 O'Clock Outflow

Pipe Height: **10.8** (in.) Rod and Bar (Angled)  
Pipe Material: **Clay** ☐ Pipe Lined  
Invert Depth: **12.70** (ft.) Flow Characteristics: **Slow**  
Deposits: ☐ None ☐ **Mud** ☐ Sludge ☒ **Debris** ☐ Grease  
Silt Depth: **2** (in.) Deposits Extent: **Light**  
Infiltration: **Evidence** Pipe Seal Cond: **Sound**

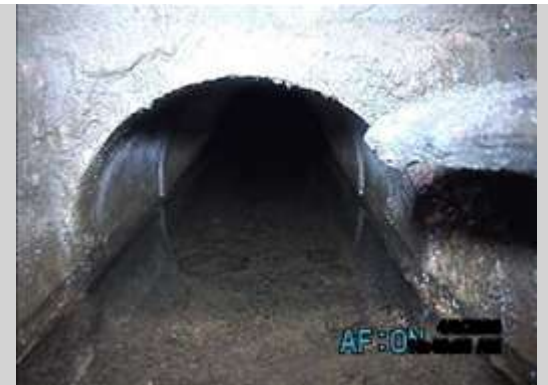
6 O'Clock Inflow

Pipe Height: **10.8** (in.) Rod and Bar (Angled)  
Pipe Material: **Clay** ☐ Pipe Lined  
Invert Depth: **12.65** (ft.) Flow Characteristics: **None**  
Deposits: ☒ None ☐ **Mud** ☐ Sludge ☐ Debris ☐ Grease  
Silt Depth: **0** (in.) Deposits Extent:  
Infiltration: **Evidence** Pipe Seal Cond: **Unknown**

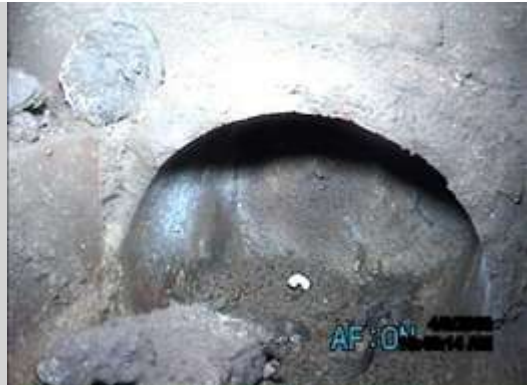
9 O'Clock Inflow

Deposits: ☐ None ☒ **Mud** ☐ Sludge ☐ Debris ☐ Grease

Silt Depth: **1** (in.) Deposits Extent: **Light**

Infiltration: **Evidence**
